TRANSPORTATION RESEARCH CENTER

ON-SITE AIR BAG INVESTIGATION

CASE NO. - 90-02  
FLEET - PRIVATE VEHICLE  
LOCATION - [REDACTED], WISCONSIN  
ACCIDENT DATE - [REDACTED], 1990

# TRC/IU ON-SITE AIR BAG INVESTIGATION

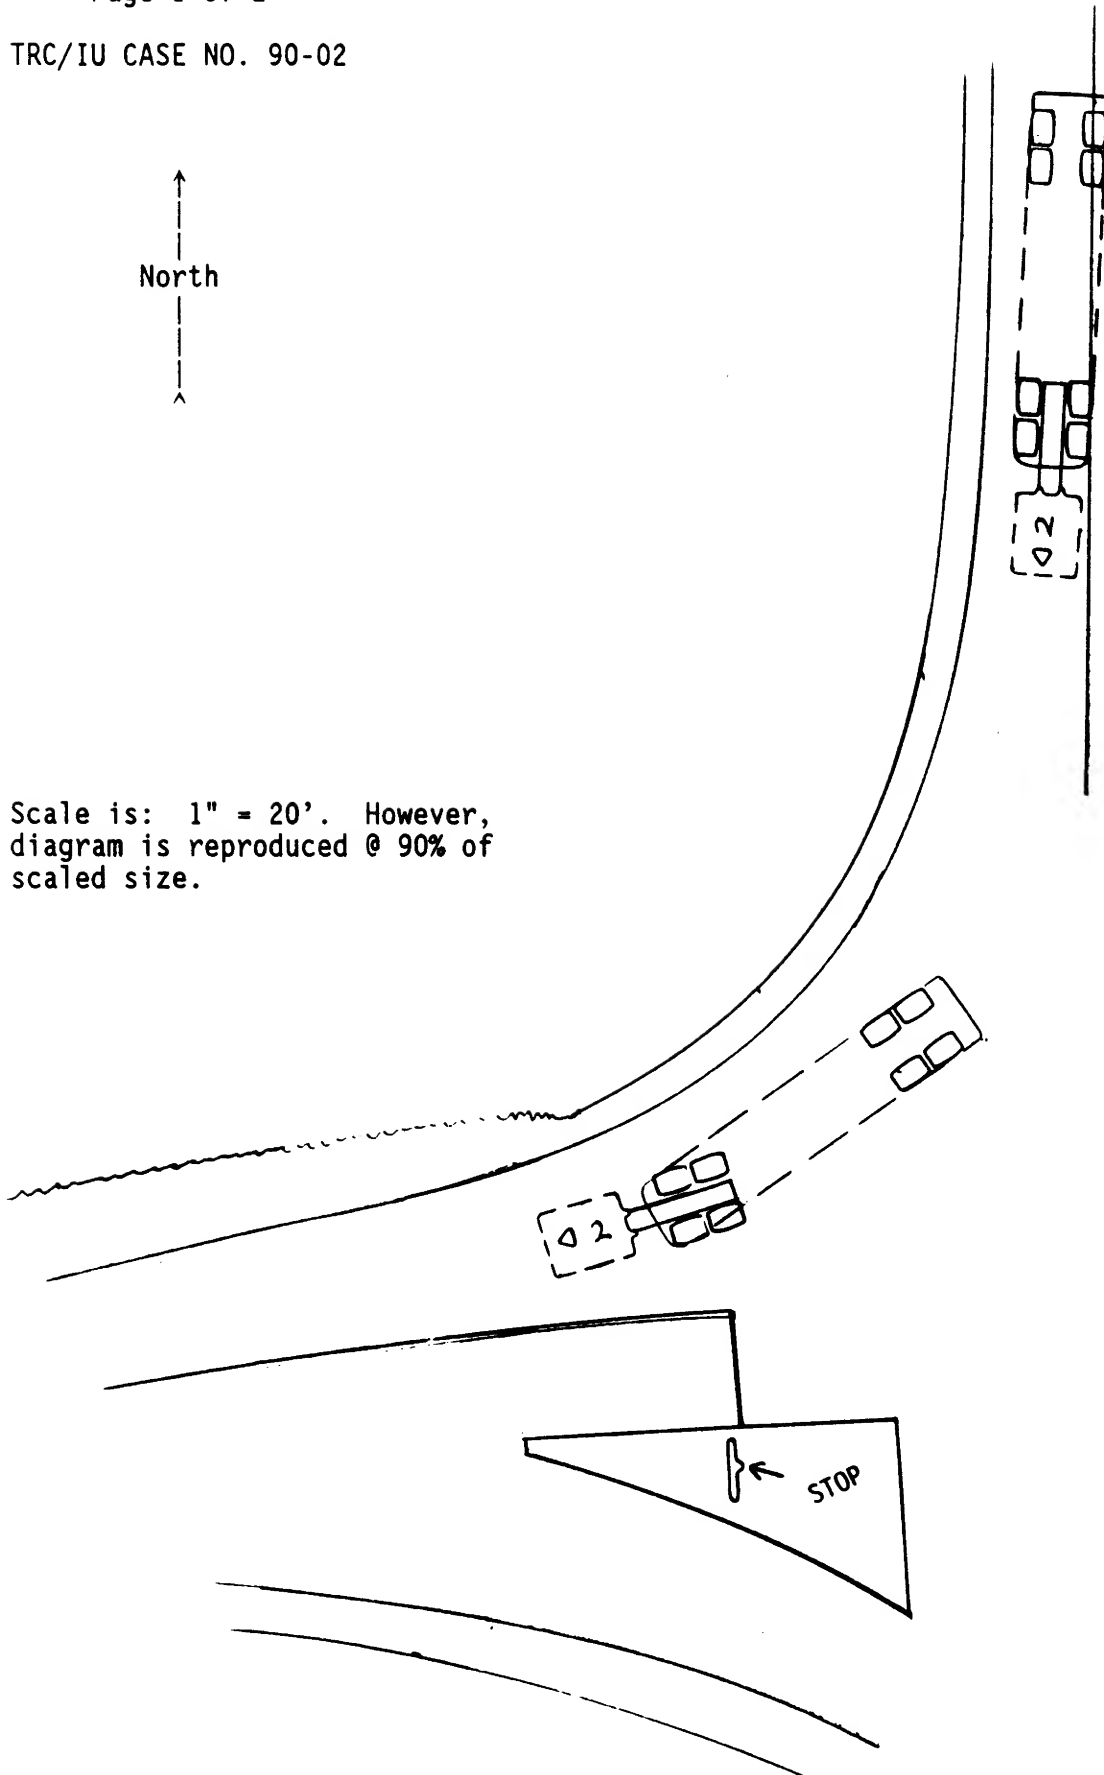
TRC/IU CASE NO. 90-02

Scale is: 1" = 20'. However,  
diagram is reproduced @ 90% of  
scaled size.

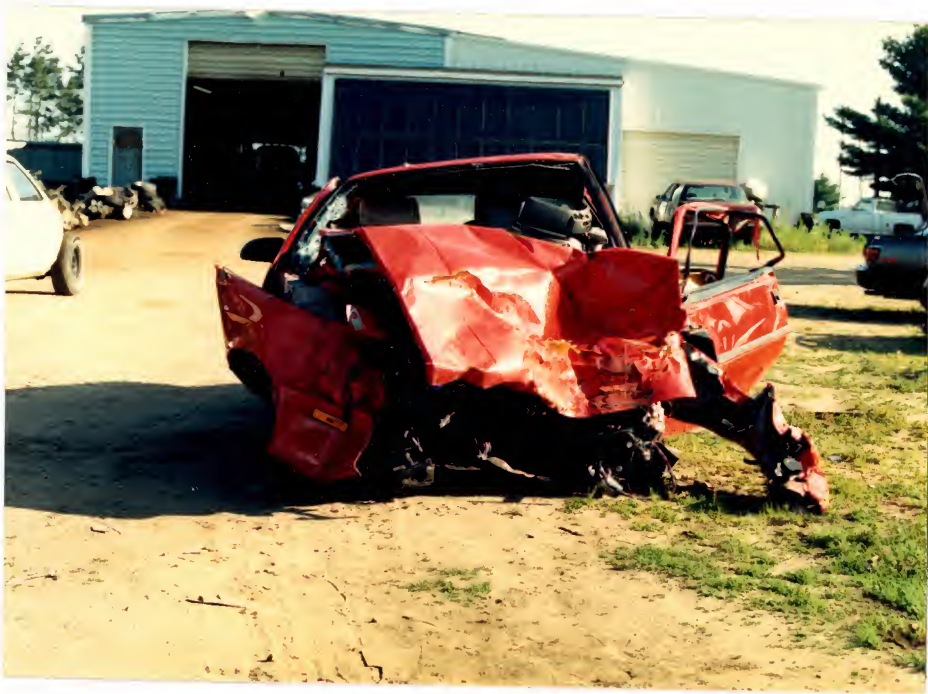
# 01 -- , 1990  
 Wisconsin  
 TRC/IU: 90-02, Task: 0069  
 Daytona frontal view

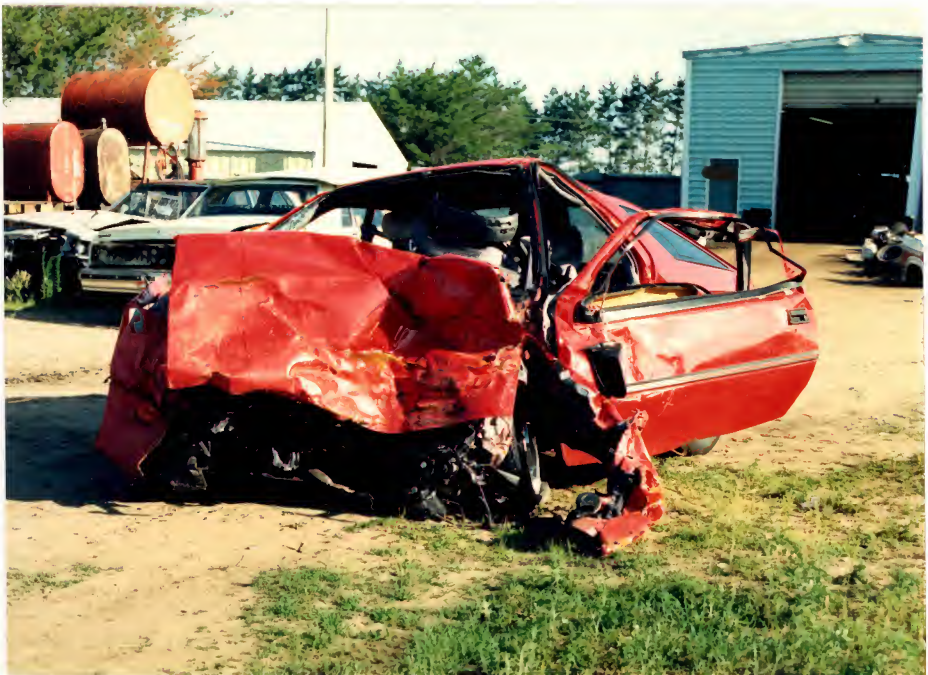
# 02 -- , 1990  
 Wisconsin  
 TRC/IU: 90-02, Task: 0069  
 Front left frontside view

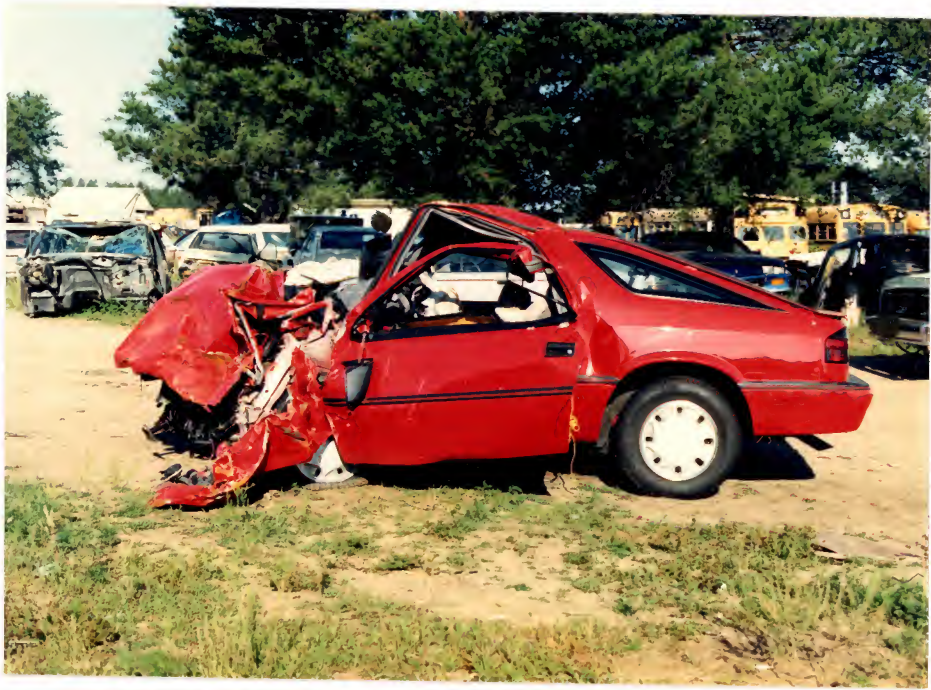
# 03 -- , 1990  
 , Wisconsin  
 TRC/IU: 90-02, Task: 0069  
 Full left side view

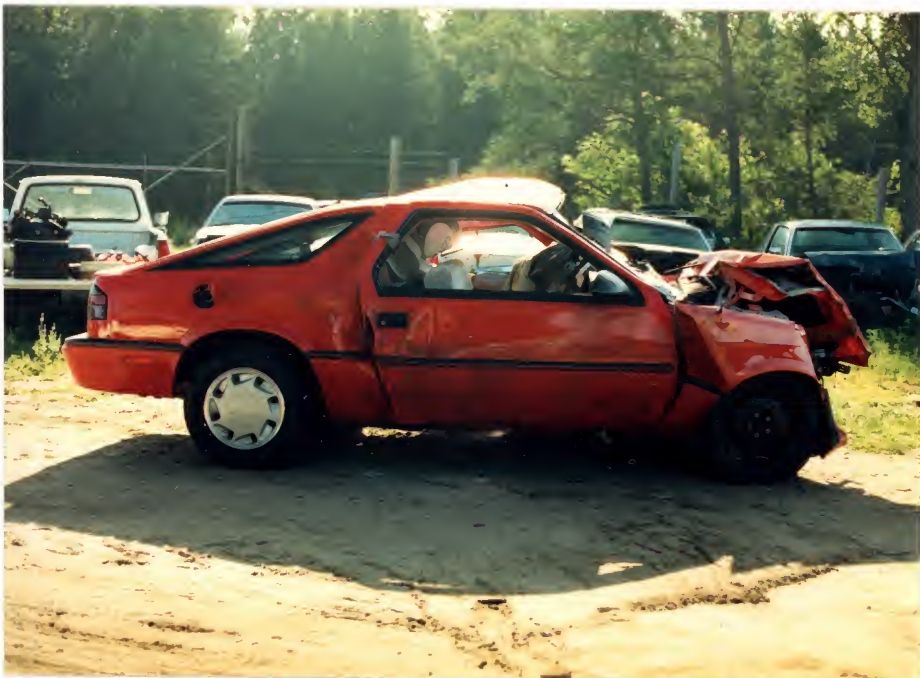
# 04 -- , 1990  
 , Wisconsin  
 TRC/IU: 90-02, Task: 0069  
 Full right side view

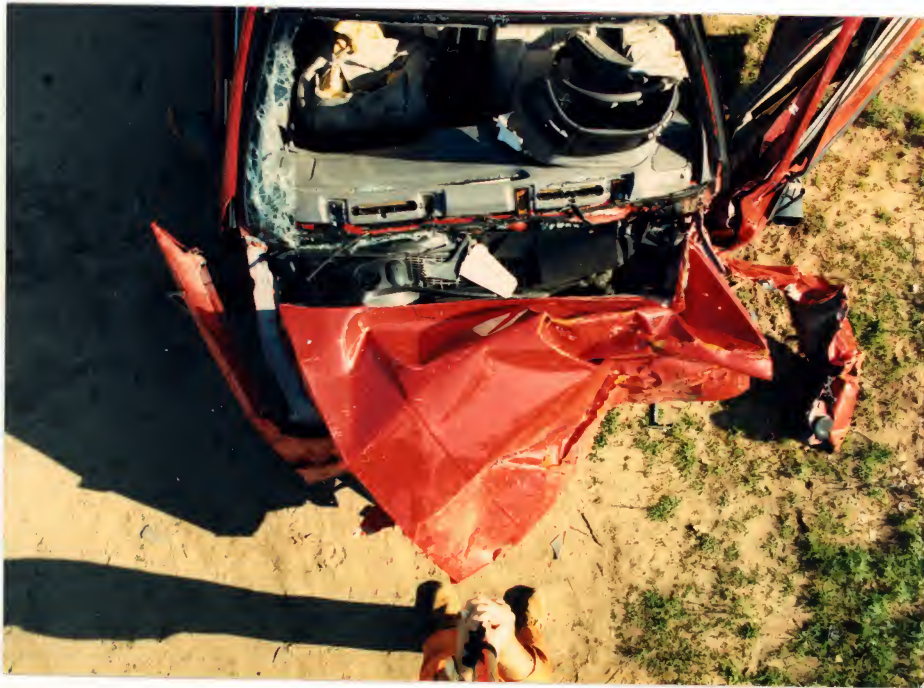
# 05 -- 1990  
Wisconsin  
TRC/IU: 90-02, Task: 0069  
Frontal sky view of damage

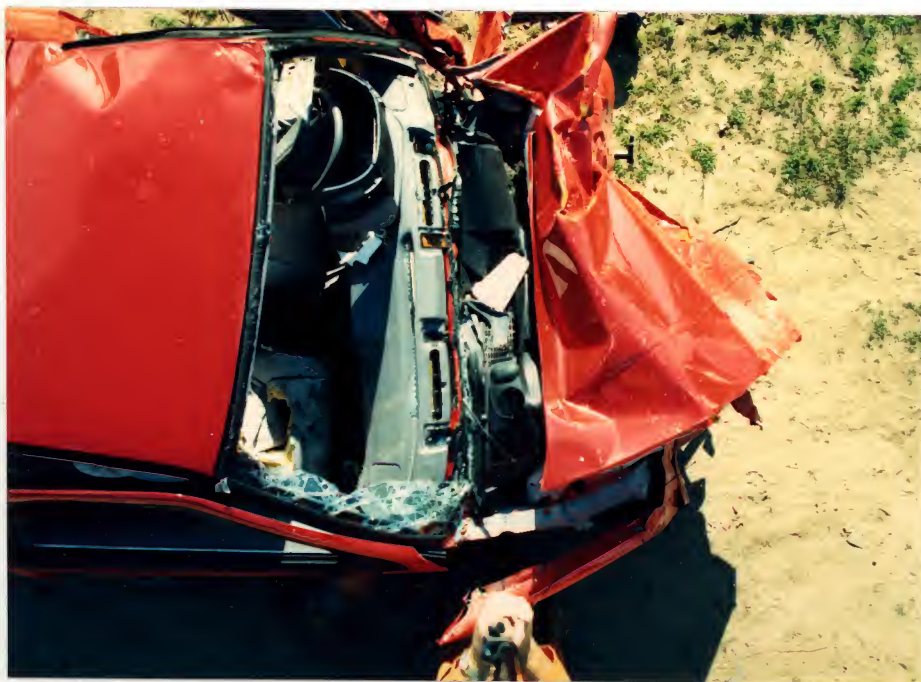
# 06 -- 1990  
Wisconsin  
TRC/IU: 90-02, Task: 0069  
Right sky view of damage

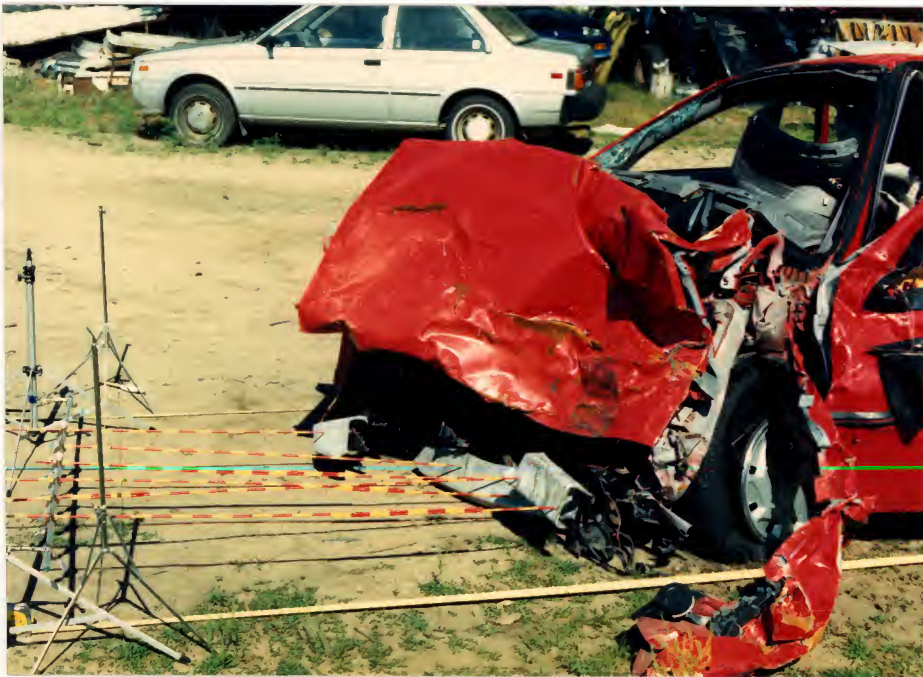
# 07 -- , 1990  
 , Wisconsin  
 TRC/IU: 90-02, Task: 0069  
 Across front from left side

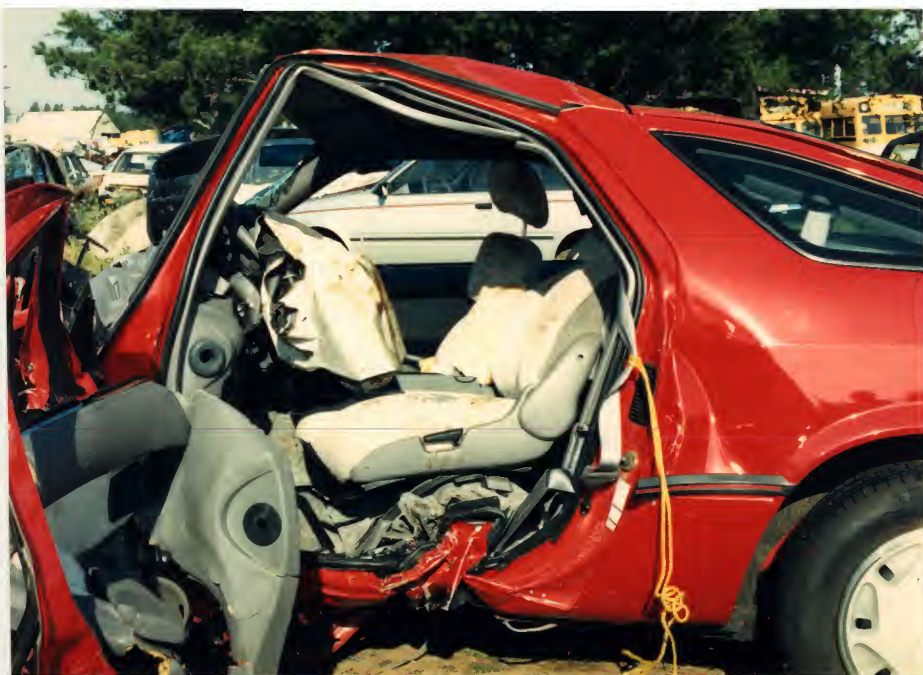
# 08 -- 1990  
 , Wisconsin  
 TRC/IU: 90-02, Task: 0069  
 Driver area from left side

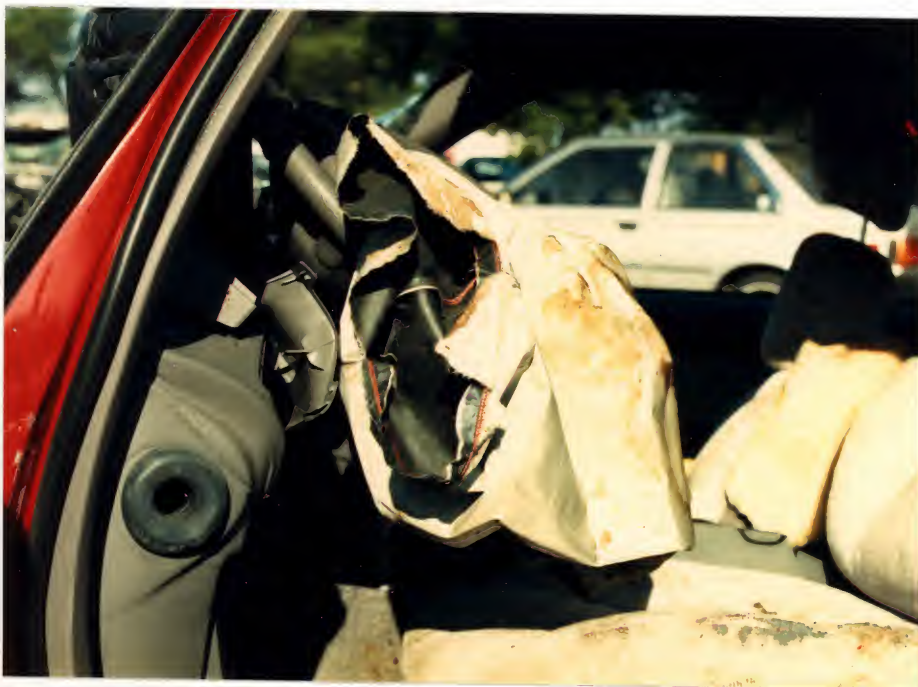
The possibility that the damage to the air bag resulted from some mechanical source was investigated and ruled out. There was no evidence that damaged or intruding components of the vehicle had interacted with the air bag. An interview with a member of the rescue crew indicated that none of the rescue operations was a possible source of the damage.

Two possible explanations for the rupture of the air bag are as follows. First, due to the proximity of the vent holes to the hub of the steering wheel, one or both of the vent holes were momentarily blocked or partially blocked resulting in the rupture. Second, the impact of the unrestrained 230 pound driver was so severe that the gas could not escape the deployed air bag rapidly enough resulting in a rupture.

# 09 -- 1990  
Wisconsin  
TRC/IU: 90-02, Task: 0069  
Closeup of ruptured air bag

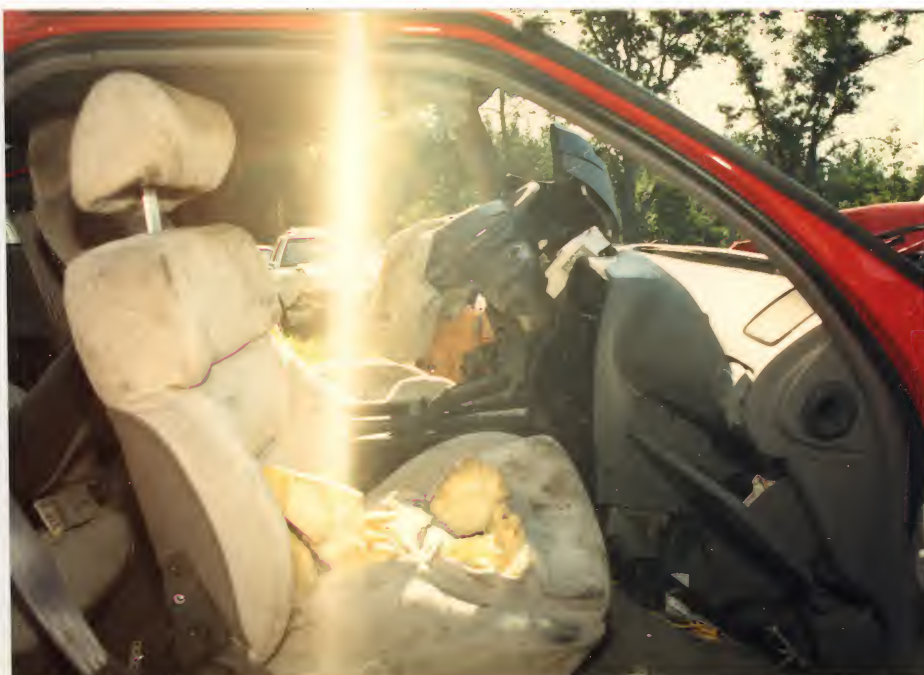
# 10 -- 1990  
Wisconsin  
TRC/IU: 90-02, Task: 0069  
Driver area from right side

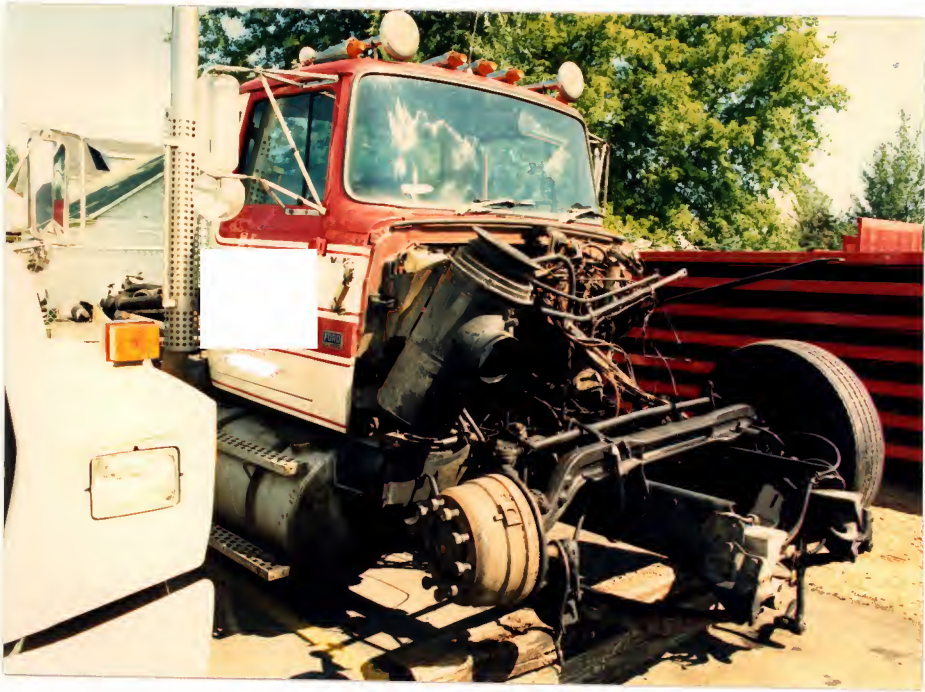
# 11 -- 1990  
 , Wisconsin  
 TRC/IU: 90-02, Task: 0069  
 Tractor front right view

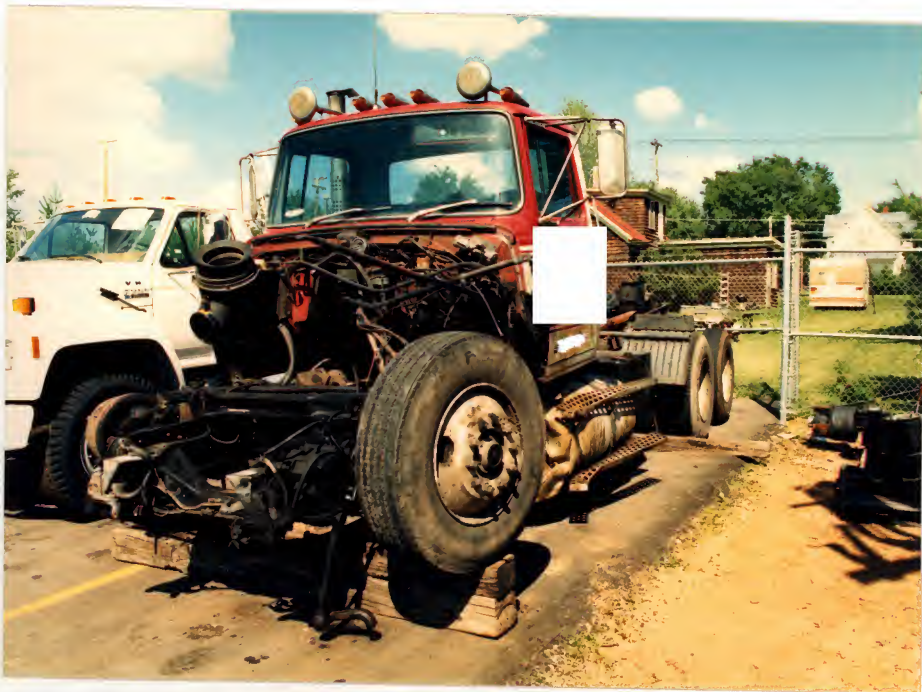
# 12 -- , 1990  
 Wisconsin  
 TRC/IU: 90-02, Task: 0069  
 Tractor front left view

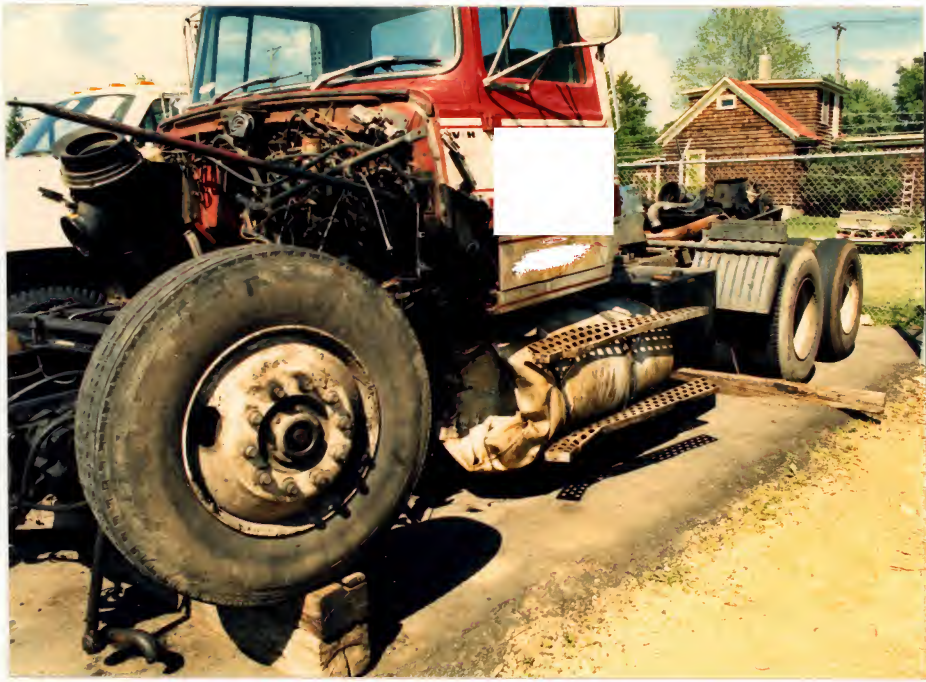
# 13 -- 1990  
Wisconsin  
TRC/IU: 90-02, Task: 0069  
Left side tractor damage

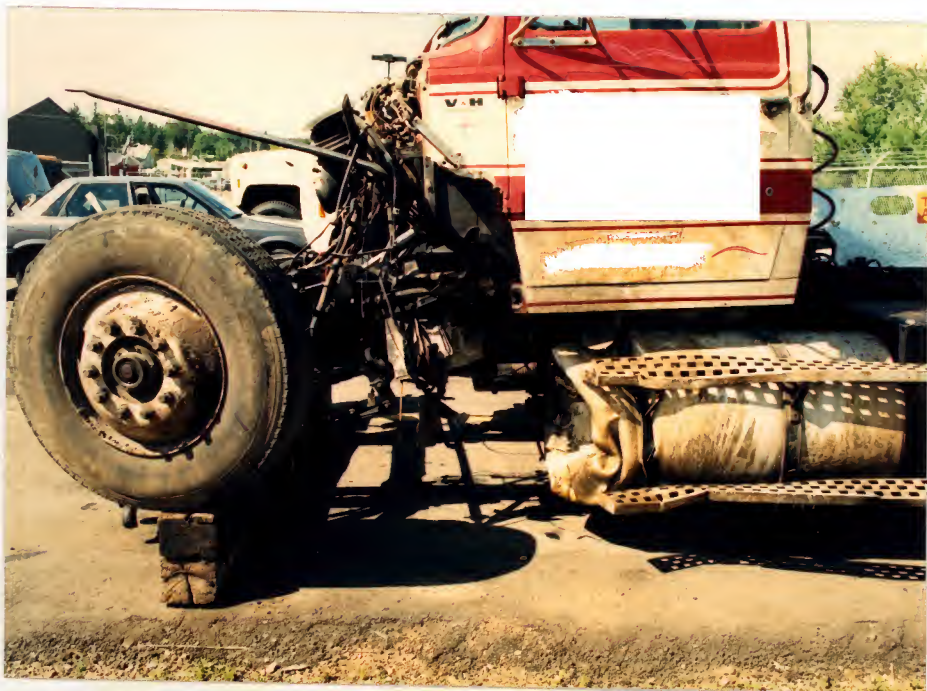
# 14 1990  
Wisconsin  
TRC/IU: 90-02, Task: 0069  
Left side fuel tank area

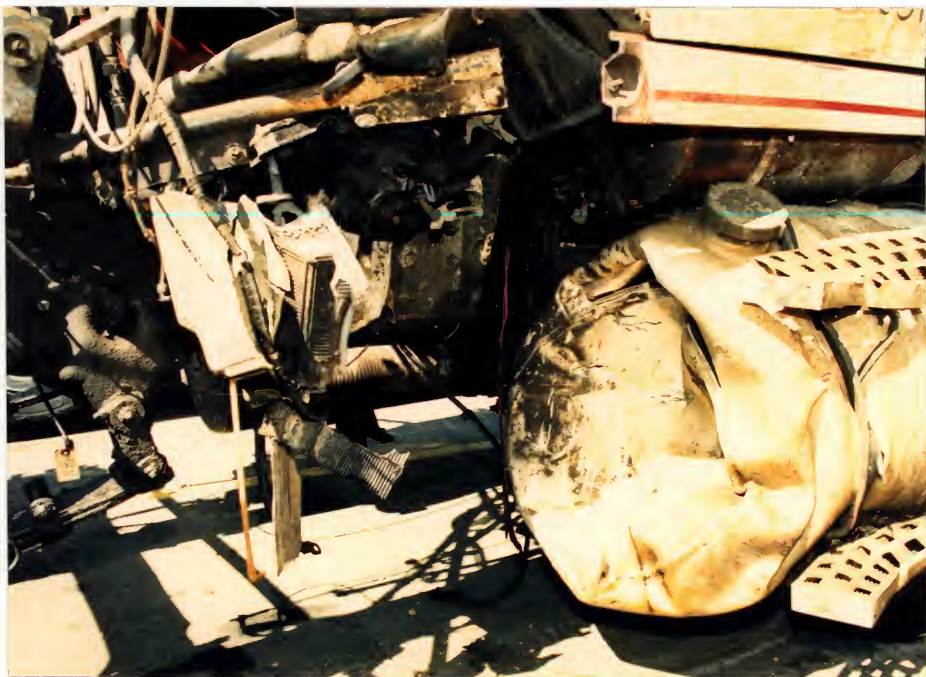
# 15 -- 1990  
Wisconsin  
TRC/IU: 90-02, Task: 0069  
Closeup left fuel tank

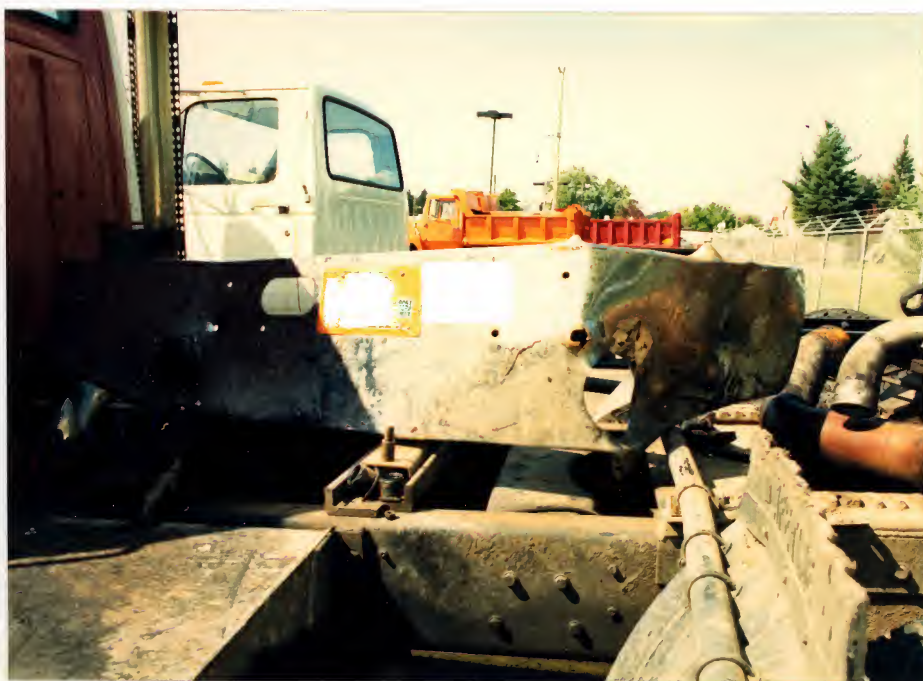
# 16 -- 1990  
Wisconsin  
TRC/IU: 90-02, Task: 0069  
Left side bumper damage

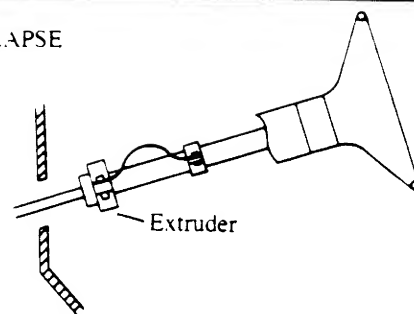
$V = 3.75"$

Direction and Magnitude of Steering Column Movement

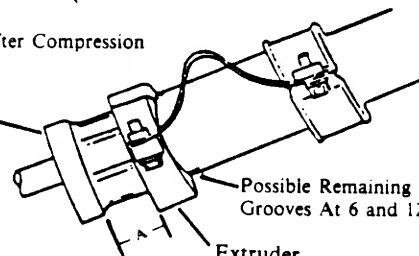
Possible Remaining Starter  
Grooves At 6 and 12 o'clock
